Original scientific paper

Root cause analysis of the corrosion-related coiled tubing failure

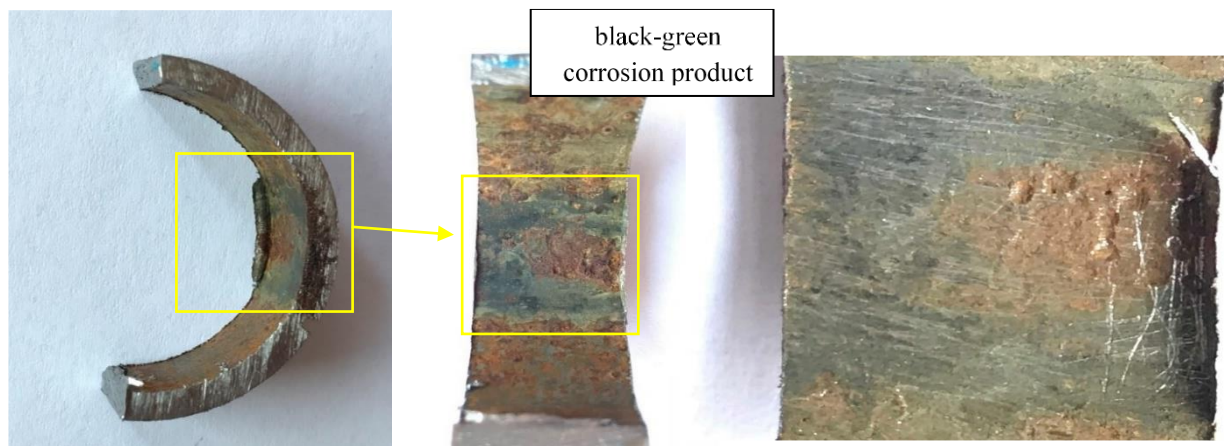
The used CT sample from the well had a metallic appearance on the outside with no visible corrosion products. On the inside, the sample was covered by a layer of brown corrosion products (Figure 2). A black-green corrosion product streak was observed longitudinally across approximately 20 % of the inner diameter.

Figure 2. Black-green corrosion product streak on a coiled tubing sample from the well

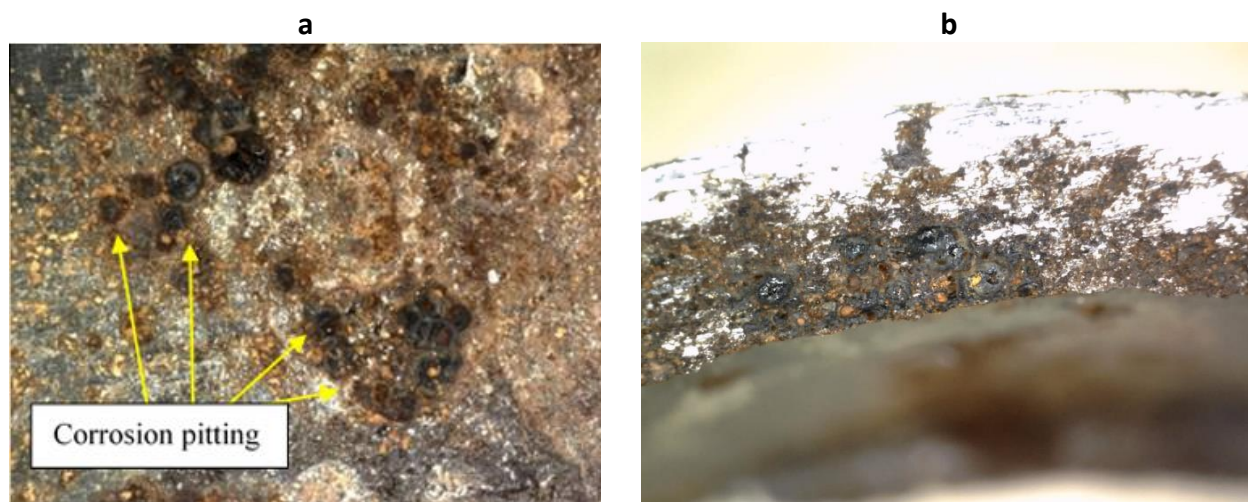
Figure 3 shows the corrosion pits and Figure 4a shows the cracks, both of which occur only within a black-green area. One of the cracks observed on the inside protruded through the wall of CT and was visible on the outside surface, as shown in Figure 4b.

Figure 3. Corrosion pits on the inner wall of the coiled tubing

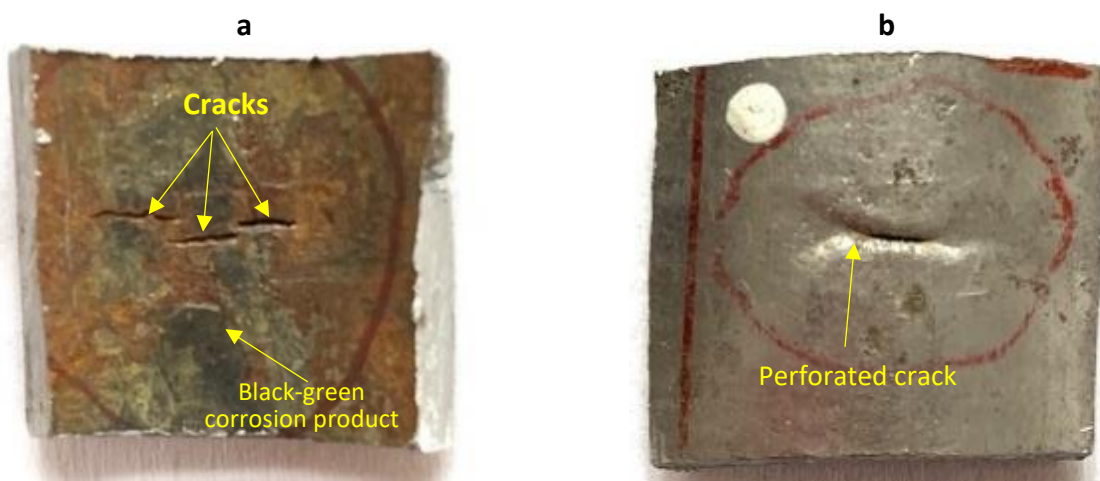
Figure 4. Cracks on a - the inner surface and b - the outer surface

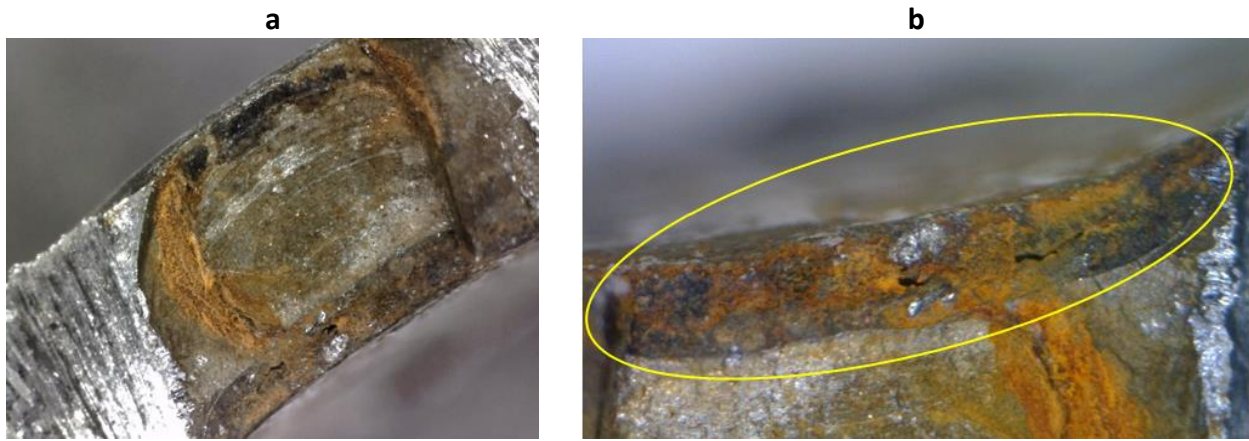
For close observation and examination, the sample was cut open to expose the fracture surface (Figure 5a). The edge of the corrosion damage in Figure 5b is the source of the striation marks and therefore likely served as the fracture origin. In the central part of the wall, a large area of striation marks perpendicular to the fracture direction was observed. The striations represent the propagation front of the fatigue crack and indicate that the fracture was caused by material fatigue. The Y-shaped crack ends shown in Figure 4b, also support the fatigue hypothesis. In addition, ridges have formed along the inner edge of the fracture parallel to the direction of fracture propagation, which can be

attributed to micro-cracking outside the central fracture plane. Terraces (stepped structures) are formed along the edges of the fracture, which are due to the initial development of the fracture in different planes.

Figure 5. Light microscope photographs of a - fracture surface and b - fracture initiation site

The number of striations is greater than the number of tube straightening and bending cycles, which may indicate a corrosion-related fatigue fracture. As the tip region of the fracture is repeatedly covered with a layer of corrosion products, the growth of the striation mark slows down. It can be argued that the numerous striation marks are due to the acceleration and deceleration of the growth of a fracture during each cycle. Becker and Lampman [12] reported that under many loading conditions, the pre-existing macroscopic crack-like defect blunts with increasing load and a new crack form by ductile tearing, creating a striation zone. Consequently, continued increase in loading causes the crack propagation mechanism to change to cleavage or quasi-cleavage.

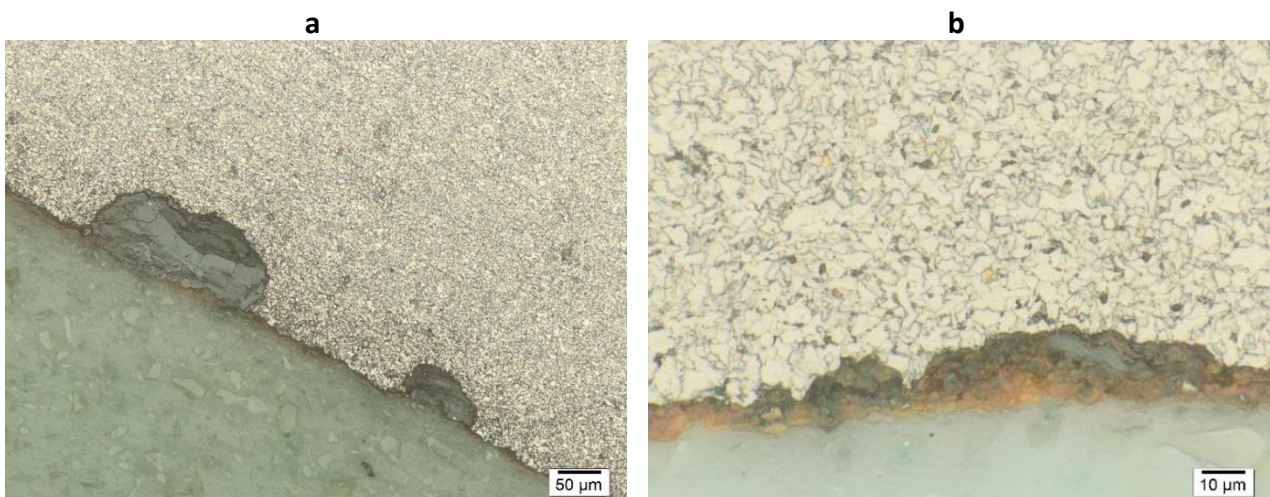
The internal surface shown in Figure 3a was examined under a metallographic microscope (Figure 6) and the corrosion pits contained a black corrosion product. Brown-orange corrosion product was seen above the black one on the surface of the shallower defects. The appearance of the corrosion damage suggests atmospheric corrosion of the steel with unobstructed oxygen flow outside the pit and a de-aerated space at the bottom of the pit. The corrosion, more pronounced on the inner diameter, is in good agreement with Still and Rolovic [13].

Figure 6. The corroded inner surface at different zones

- To prevent storage corrosion, it is necessary to properly maintain the tubing between acidizing operations by the following procedures:
 - nitrogen purging, preferably using a polyurethane ball to expel electrolytes from the tubing and subsequent capping the tubing ends,

- application of vapor phase corrosion inhibitors.

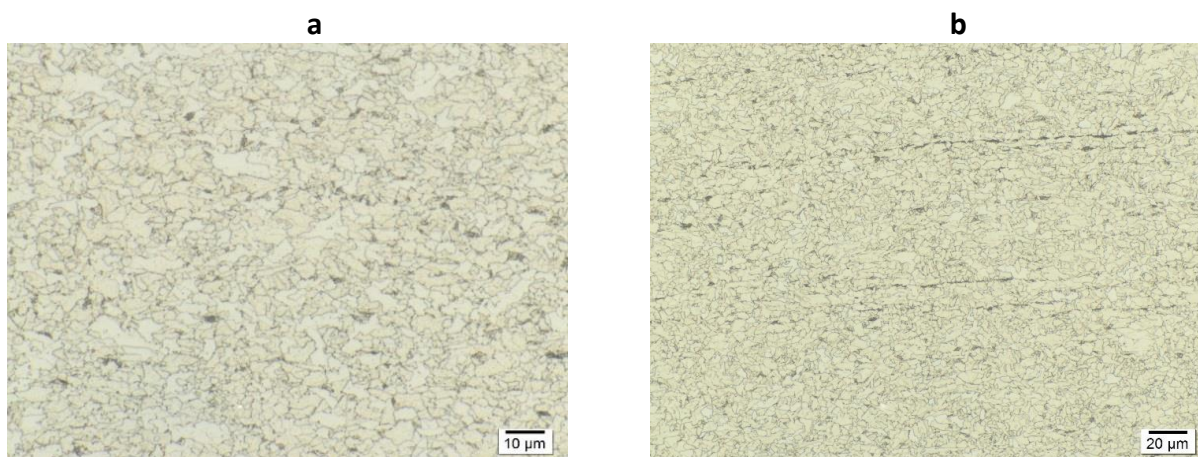
The polished and etched used CT had a fine-grained microstructure (ASTM sizes 13 to 14) with evenly distributed areas of ferrite and pearlite and some bainite, as shown in Figure 7a. Short banded structures of pearlite are observed in some places in the centre of the wall section (Figure 7b). No cracks are visible on the metallographic samples.

Figure 7. Fine-grained structure of quasi-polygonal ferrite with uniformly distributed areas of pearlite and bainite

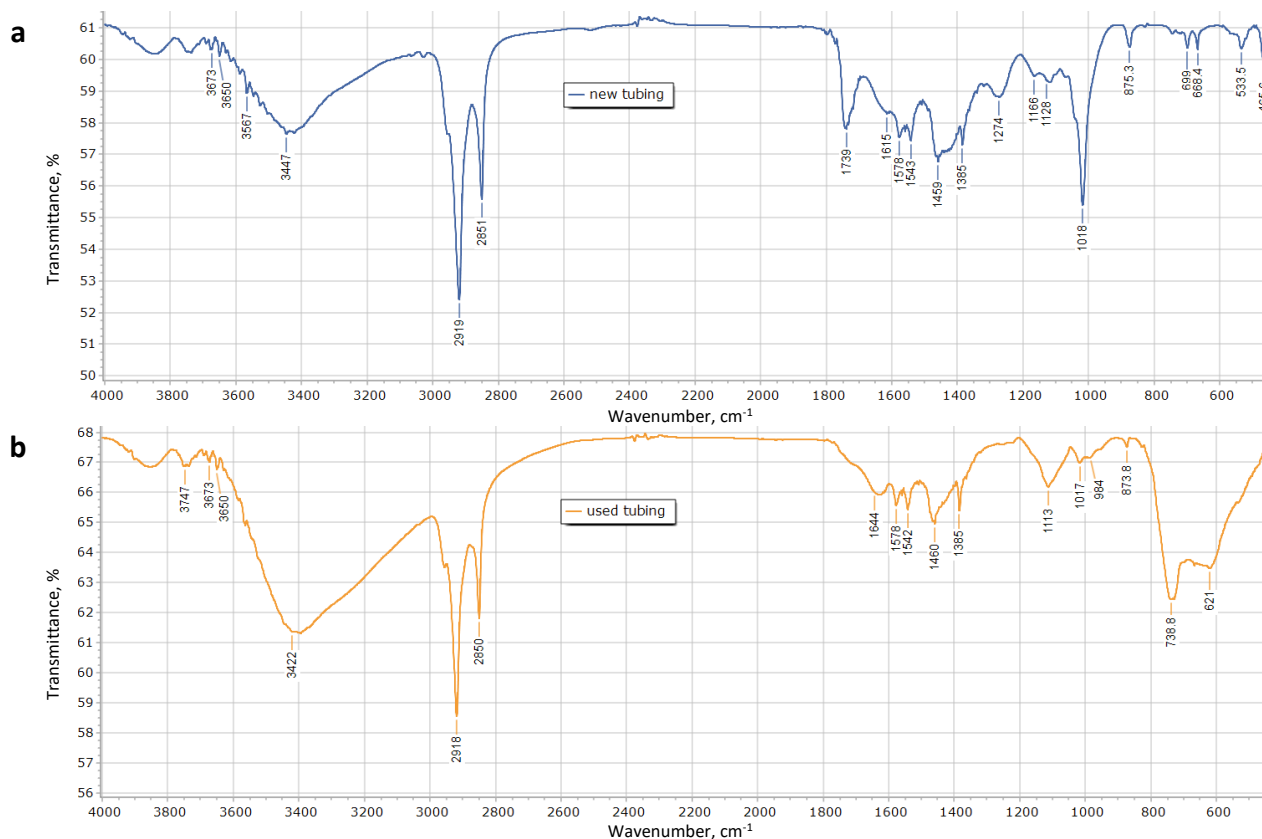
The layers on the inner surfaces of the new and used CT samples were rubbed with KBr, which was later pressed into pellets for FTIR analysis. The FTIR spectrum of the new CT sample, Figure 8a, shows no clear bands of iron oxides, confirming the absence of corrosion on the inner diameter of the new CT sample. The observed bands indicate the presence of an organic corrosion inhibitor used by the manufacturer of the CT. The FTIR spectrum of the used sample CT is shown in Figure 8b and indicates the presence of antimony oxide. Antimony salts were used as a component of the acidizing corrosion inhibitor and the inner surface of CT is partially covered with deposited metallic antimony, which oxidizes to antimony oxide when exposed to air.

Figure 8. FTIR spectra for a - new tubing and b - used tubing from the well

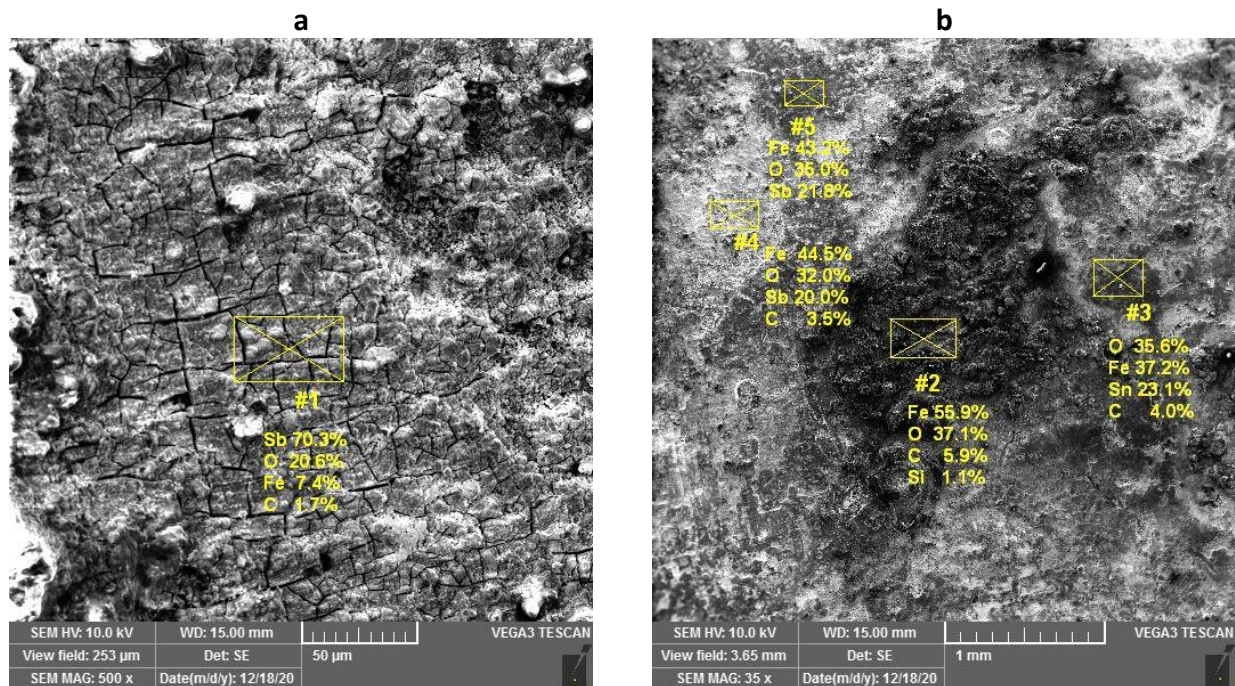
Figure 9a shows a cracked but layer of antimony at the inner surface of the used CT (measurement point #1), located away from the analysed crack. The inner surface near the crack in

Figure 9b shows that no continuous antimony layer is present (measurement points #3 to #5), and in particular, no antimony is found within the pit (measurement point #2)

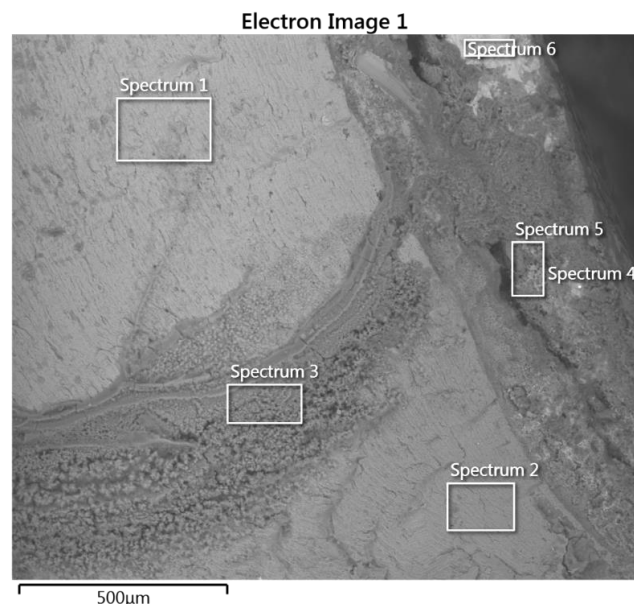
The EDS was performed at different locations on the fracture surface (Figure 10). Representative EDS spectra are shown in Figure 11, and the results are summarized in Table 2. The EDS elemental analysis of the fracture indicates elements that can originate from the metal substrate (Fe, Cr, Si, C) or the environment (O, C, S, Si, Cl, Sb). Carbon can originate from the organic component of the corrosion inhibitor. Small amounts of sulfur were detected during the test. The sulfur could be from H₂S from the environment and/or microbiological corrosion induced by sulfate-reducing bacteria (SRB). However, the amount of sulfur is minimal and the source of the sulfur could not be clearly determined from this analysis. The presence of sulfides was not detected by the lead acetate paper test.

Figure 10. EDS spectra locations at the fracture surface of the perforated sample

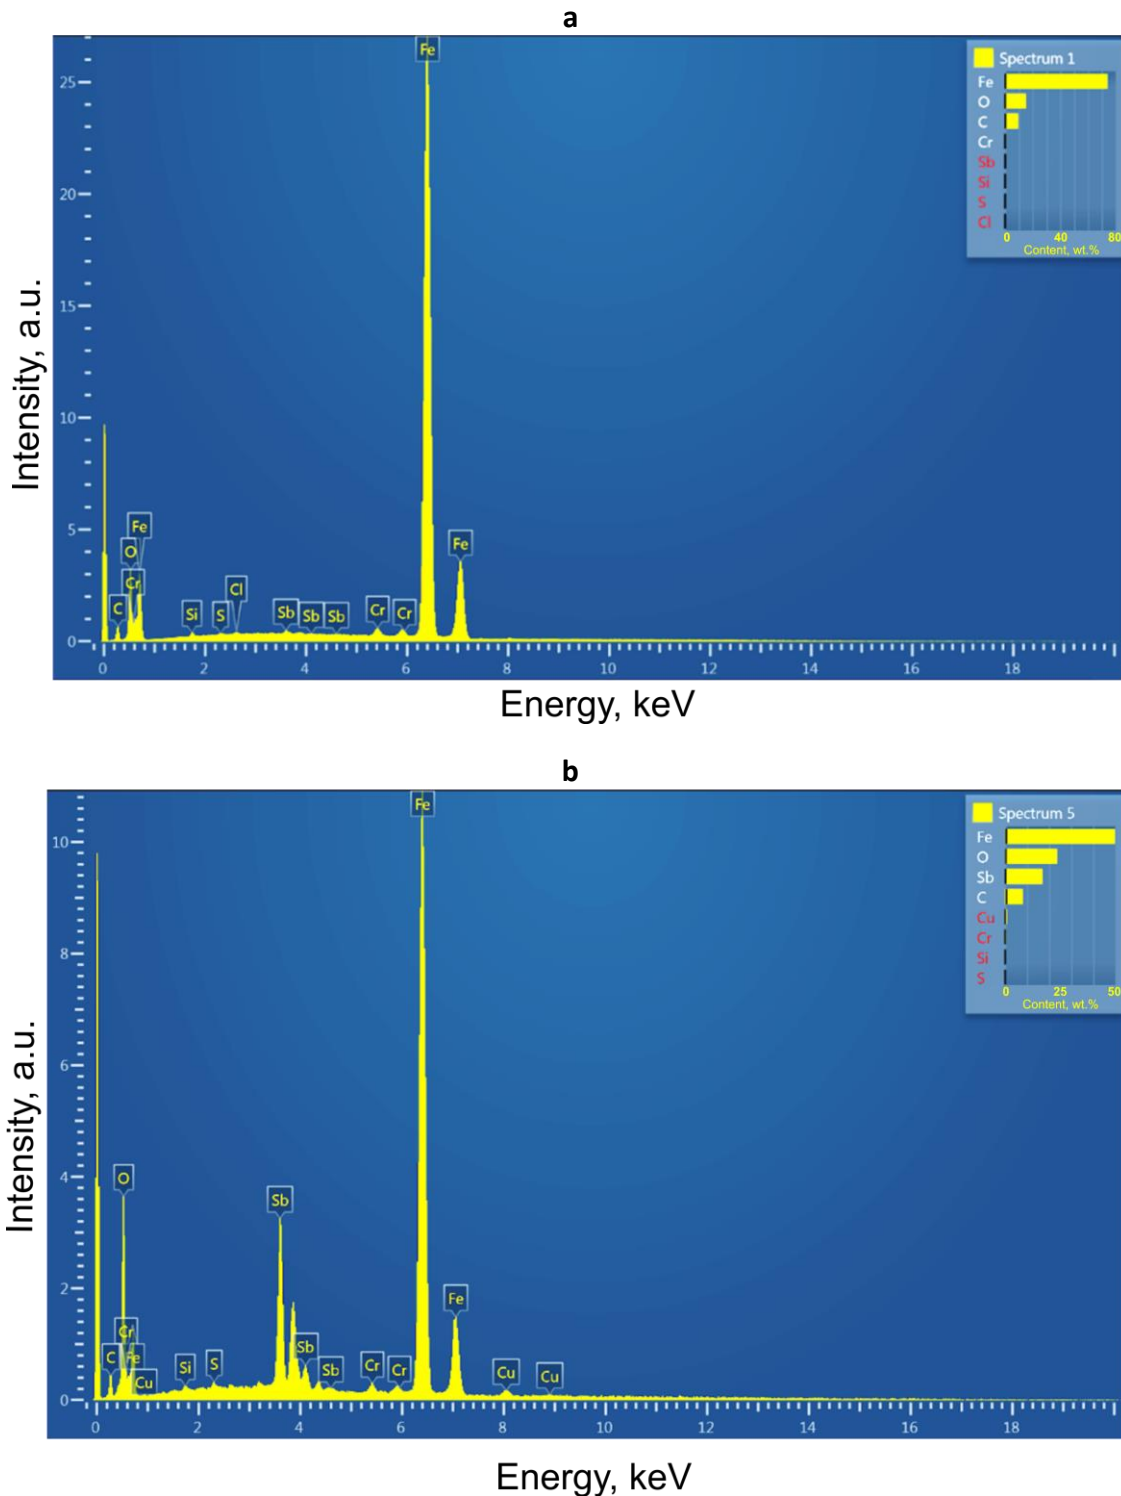
Figure 11. Representative EDS spectra of the fracture surface in Figure 10 at different locations: **a** -location 1 and **b** - location 5

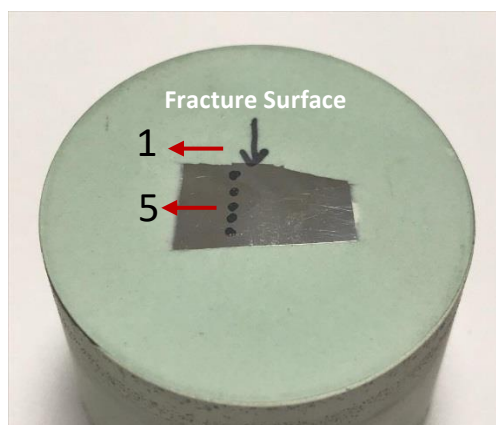
Figure 12 shows the locations where the hardness measurements were made, and the results are summarized in Table 3. The hardness values were relatively consistent and agreed well with the declared value of 91.87 HRB (190 HV) of the CT-80 tubing parent material. Given the relatively small grain size (ASTM 13 to 14) and the fact that hardness decreases with decreasing grain size, this is the expected value of the measured hardness. H. Ghiasi [14] reported that the microstructure affects the improvement of properties and fatigue life. By decreasing the grain size, the mechanical properties and fatigue life increased.

**Figure 12.** Vickers microhardness examination sites**Table 3.** Vickers hardness values near the fracture at different locations
